# Review on Experimental Analysis of CAM Roller of Petrol Engine by Change in Profile

UG Students, Department of Mechanical Engineering

VOGCE, Aghai, Mumbai University

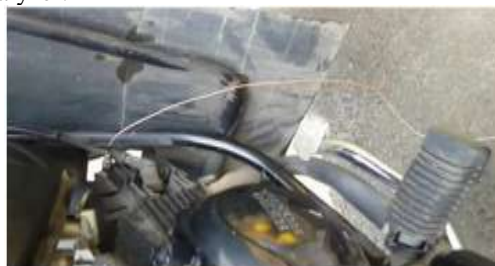
Fig.2 Vibration Analysis

**Vibration Analysis:** The accelerometer is first attached to the engine magnetically and then the sensor is held in front. The data is then collected in FFT analyzers.

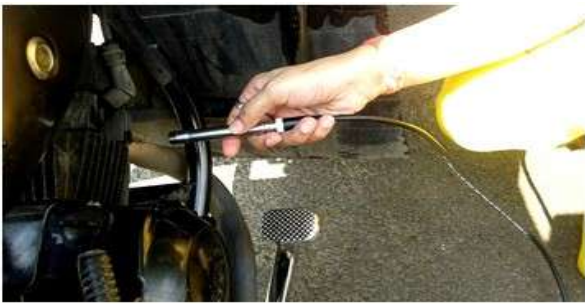
Fig.3 Noise Analysis

**Acoustic analysis:** For this test noise sensing probe was held in front of the engine. The readings were been analyzed in FFT analyzer.

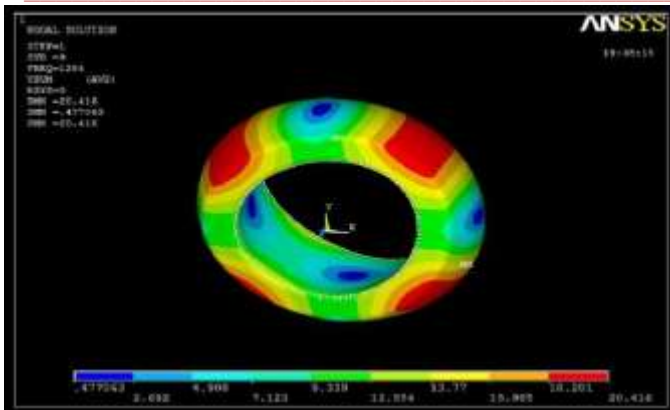
Fig 8 1206Hz frequency

The nodal analysis of the new roller at three different frequencies ranges 828.32Hz, 1206Hz, and 3272.8Hz.
